# Studebaker

# SERVICE BULLETIN

NO. 201

1948

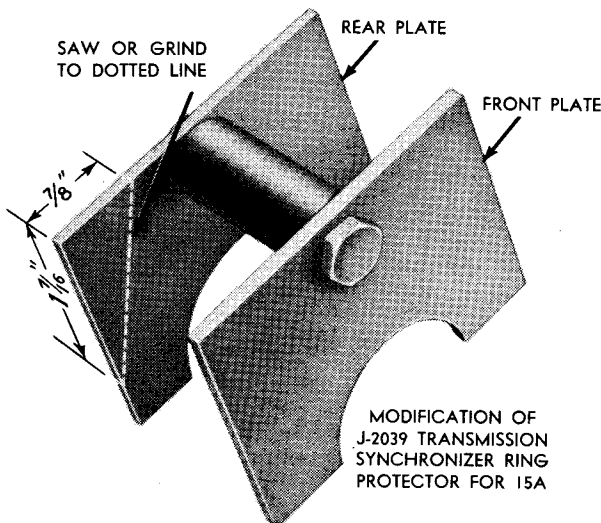
The accompanying illustration shows how the transmission synchronizer ring protector, Tool No. J-2039, can be modified for use with the 1948 Commander and Commander Land Cruiser models. This modification in no way affects the utility of the tool for transmission work on earlier Commander models.

The 15A transmission has an oil pick-up trough running the full length of the case which makes it necessary to insert the Trans-

mission Synchronizer Ring Protector (Thrust Yoke) at a slight angle. This cannot be done without cutting the upper left corner of the rear plate (facing the tool with the semi-circles downward), as shown, to clear the lip of the case at the center cap screw hole.

Tool No. J-2039 modified as described above may be obtained direct from the Kent-Moore Organization, Detroit, for \$5.80.
