Studebaker

# SERVICE BULLETIN

NO. 234

1949

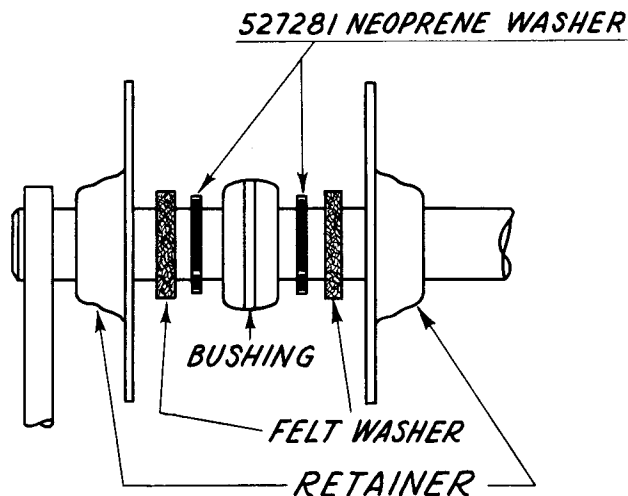
A rattle in the clutch operating shaft can be eliminated in the 6G-9G models inclusive and 14A-17A models inclusive by the use of two Neoprene washers, Part No. 527281. Two of these washers, used as directed below and described in the accompanying illustration, will prevent noise in the clutch operating shaft parts, in cars produced prior to Serial Nos. G485212 (9G) and 4404905 (17A).

1. Remove operating shaft and bushing and retainer assembly and disassemble.
2. Inspect shaft. If it shows signs of wear, replace shaft.
3. Disassemble the bushing and retainer assembly, replace any worn parts, and reassemble, using two of the new Neoprene washers, Part No. 527281. The parts should be assembled in the following order:

- (a) Metal retainer
- (b) Felt washer
- (c) Neoprene washer
- (d) Bushing
- (e) Neoprene washer
- (f) Felt washer
- (g) Metal retainer

4. Thoroughly lubricate the assembly with SAE 30 engine oil and reassemble with the shaft in the car.

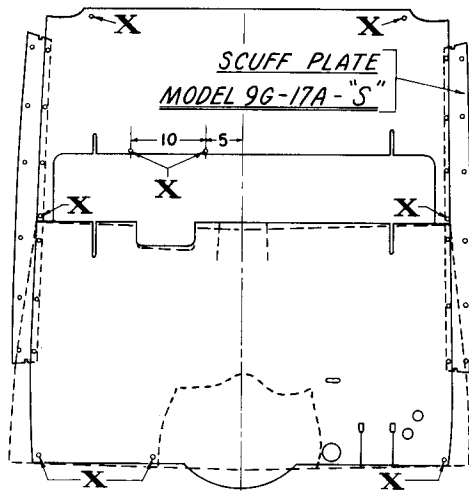
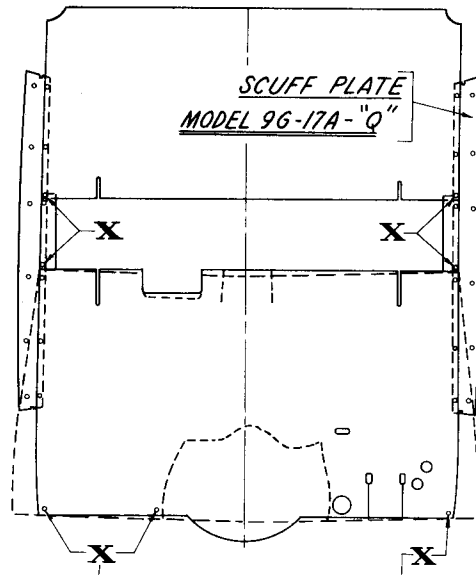
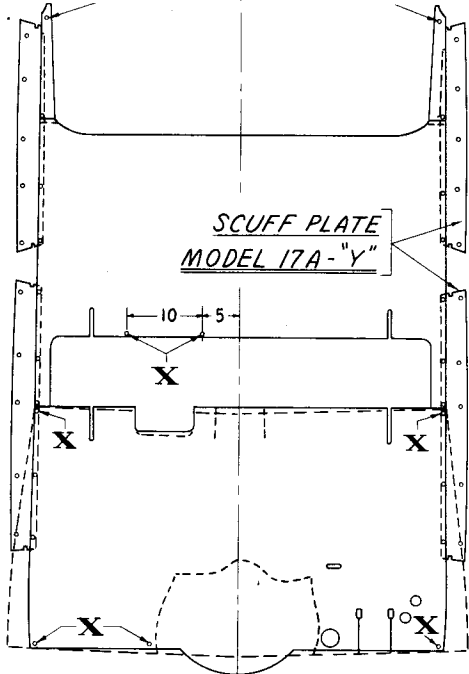
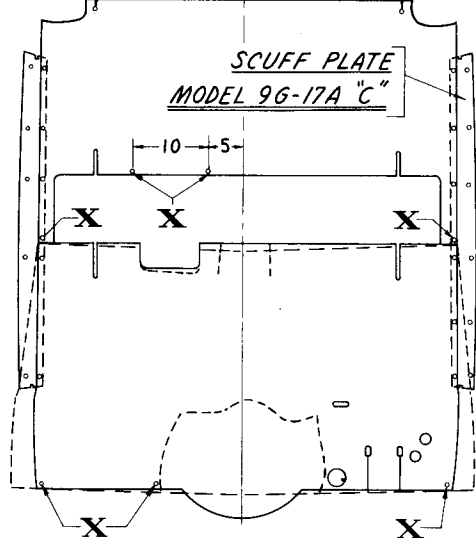
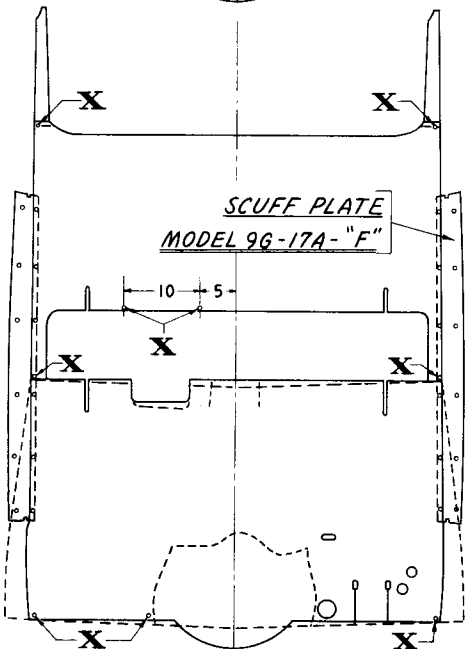
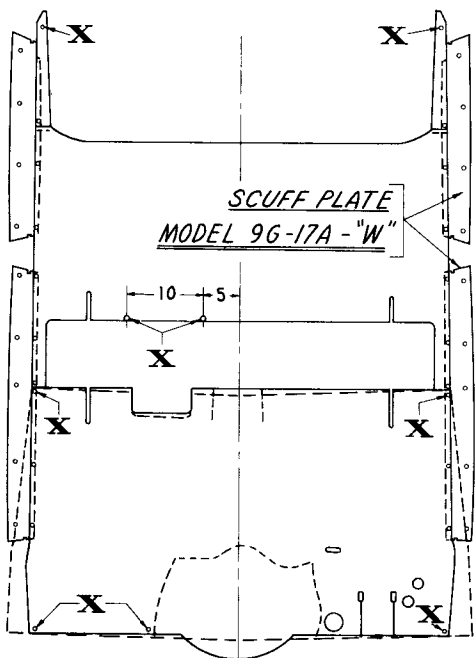
Careful installation of floor mats and carpets before the new car is delivered to the customer is important not only for purposes of appearance, but is also important to assure proper air flow to both front and rear compartments from the Climatizer either in summer or winter.

The drawings at the right show the location of installation screws for installing floor mats and carpets in the various body styles of 9G Champion and 17A Commander models.

The inner scuff plate screws are removed, mat or carpet laid, and the scuff plate screws reinstalled to fasten the floor covering at those points. Additional screws (provided in an envelope placed in the package compartment) are to be installed at the points designated by the large letter X on the drawings.

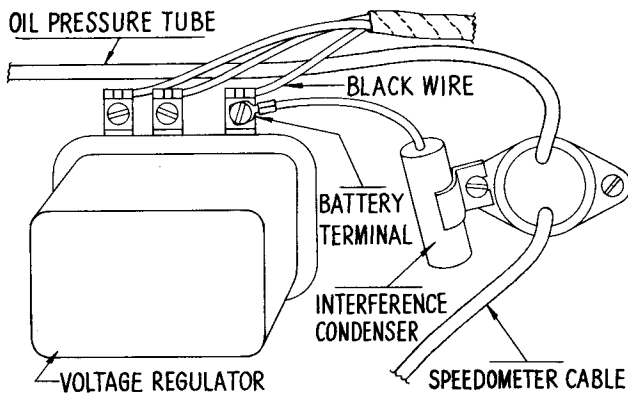
**SUPPRESSION AT VOLTAGE REGULATOR**

An objectionable interference to good radio reception has been noticed in 1950 Commanders and Land Cruisers. This has been traced to the car's electrical system.

One condenser is fastened to the battery (BAT) terminal of the current and voltage regulator and the condenser bracket is grounded to the engine side of the dash at the innermost mounting screw of the grommet containing the speedometer cable and the oil pressure gage tube, as shown below.

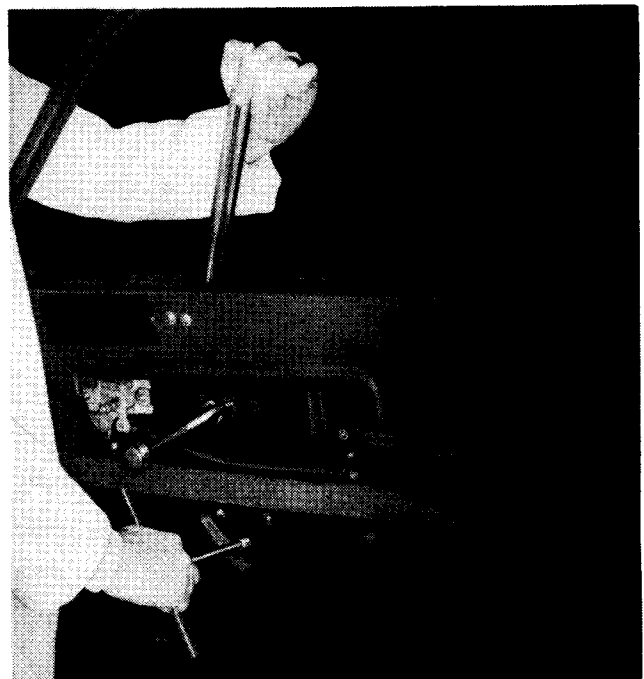
The window regulators used with ventilator-type door windows will, in some cases, permit the window to be lowered below the moulding. These windows may rattle when in the fully lowered position. To correct such cases, the trim panels and the regulator mounting screws should be removed and the mounting holes filed upward until the regulator can be mounted high enough to position the top edge of the window glass approximately 3/8" above the moulding when in the fully lowered position. See the accompanying illustration for location of the window regulator mounting screws.

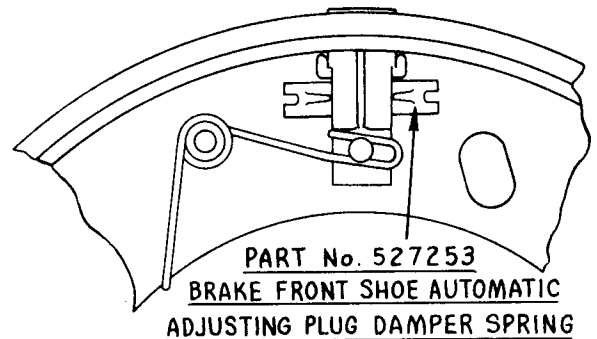
A brake squeak that can be traced to the self-adjusting plug of the forward brake shoe on 6G, 7G, 8G and 9G Champion models and 14A, 15A, 16A and 17A Commander models and 2R5 series truck models, can be eliminated by the use of a Damper Spring, Part No. 527253. The spring is inserted between the self-adjusting plug and the web of the brake shoe at all four wheels. This change was incorporated in production on all passenger cars and 2R5 trucks beginning approximately October 1, 1949.

Installation of these springs should be made as shown in the accompanying sketch and by the following procedure:

1. Remove the wheel, hub and drum assembly.
2. Slide the spring, Part No. 527253, between the flat side of the self-adjusting plug and the web of the brake shoe, with the concave face of the spring toward the web of the shoe.
3. Center the spring and make sure the tabs on the spring on either side of the self-adjusting plug are raised to hold the spring in position.
4. Push self-adjusting plug down until it is flush with or slightly below the surface of the brake lining.
5. Install the wheel, hub and drum assembly.
6. Make brake application and adjust brakes as required.

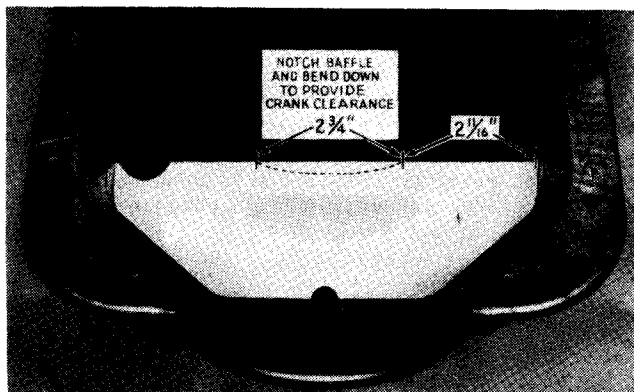
Engine noise in a few cases has resulted from interference between the oil pan baffle and the cheek of the No. 5 crank on the crankshaft. In production, a notch and a depression have been placed in the baffle in the oil pan to provide clearance for the crank cheek at this location.

Should any interference of this kind be noticed in Champion-type engines brought to your service department, it will be necessary to remove the oil pan, notch the baffle and bend it downward at the point of interference as shown in the accompanying illustration.

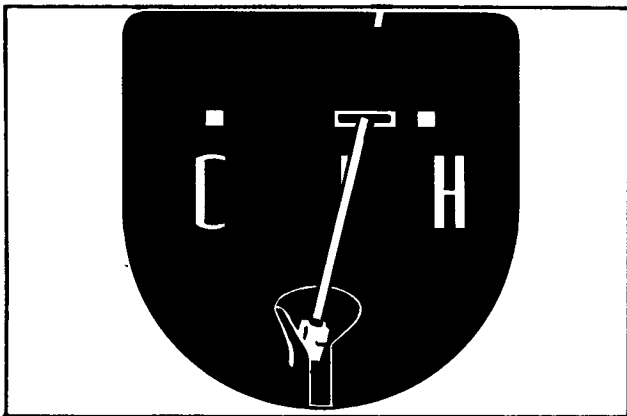
Effective with production of 9G Champion Serial No. G498915 and 17A Commander Serial No. 4410219, the marking on the face of the instrument panel heat indicator was revised to include a white outline block in the normal driving temperature range as shown in the illustration below.
