Studebaker

SERVICE BULLETIN

NO. 241

1950

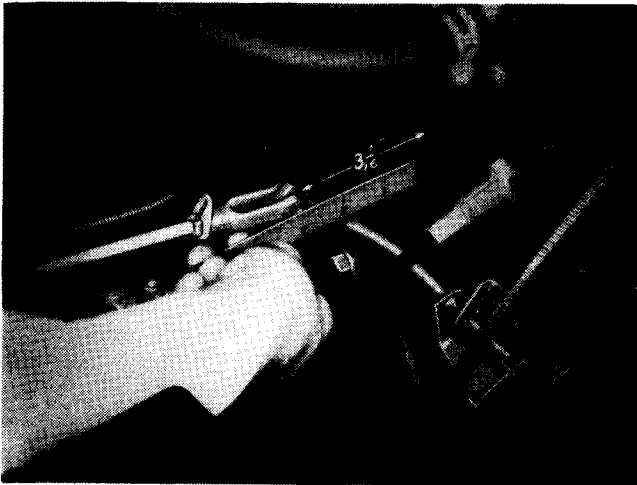
In making the accelerator-to-transmission control linkage adjustment on the Studebaker Automatic Drive, it is desirable to have a point of reference to which all subsequent adjustments can be related or compared.

This point of reference is the measurement of 3-1/16" (see illustration) which should exist between the firewall and the center of the clevis pin at the accelerator cross shaft when the accelerator is in the fully released position. With this measurement correct, following the adjustment procedure printed in

1. With the accelerator fully released, measure the distance between the center of the clevis pin at the accelerator cross shaft and the flat portion of the firewall (not at the rib). This distance should be 3-1/16". If it is not 3-1/16", adjust the clevis, using the adjustable rod until there is 3-1/16" between the center of the

clevis pin at the accelerator cross shaft and the firewall. This adjustment must be made first.

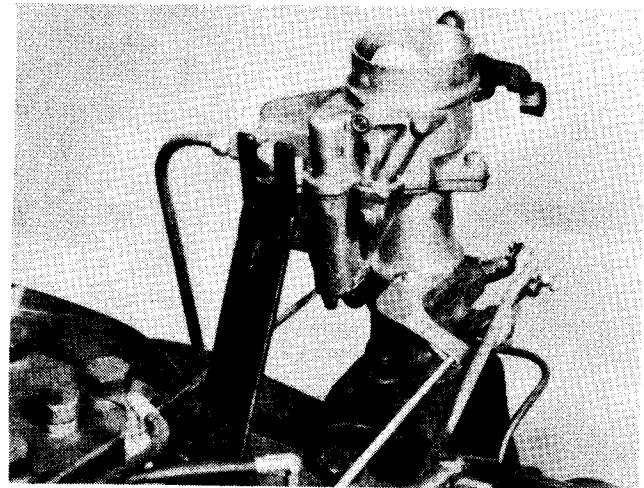
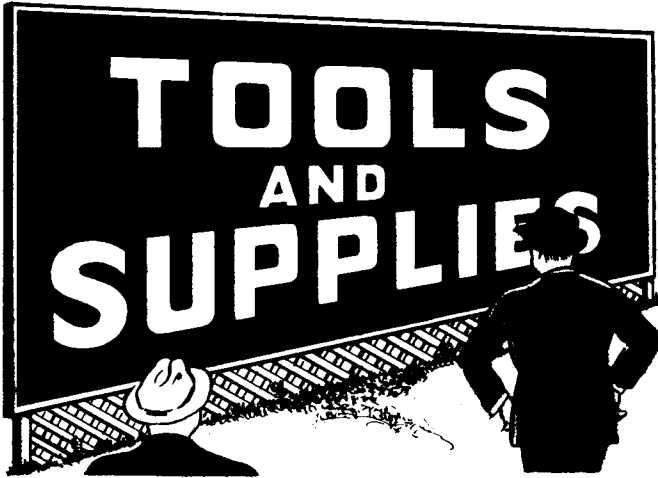
The illustration shows the correct method of
mounting the hand throttle Bowden wire adapter
plate and tightening screw on 2R Series Trucks.

When this plate and screws are assembled, the
tightening screw is installed in the reverse
position to that shown in the photograph above.
To assure ease of tightening when installing
the hand controls, it is necessary to remove
this screw and reinstall it from the top of the
plate before the Bowden wire is secured in the
clip.
