Studebaker

# SERVICE BULLETIN

NO. 247

## SERVICE DATA - H AND IOG MODELS

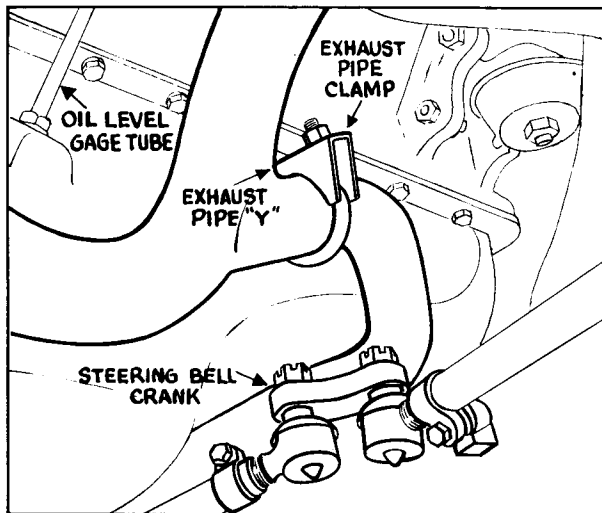
7. **EXHAUST PIPE CLAMP U-BOLT POSITION - MODEL H**

On early production 1951 Commander models, there is a possibility the exhaust pipe clamp U-bolt may have been improperly positioned. This exhaust pipe clamp U-bolt should be positioned so that the nuts are upward toward the engine block. This is important since the open end of this U-bolt, if pointing downward, may interfere with the steering bell crank.

You should check all 1951 Commanders thus far received to determine if this U-bolt is properly positioned. If it is not, loosen the nuts and move the U-bolt and the saddle until the correct position is reached as shown in the accompanying drawing. Then, retighten the nuts.

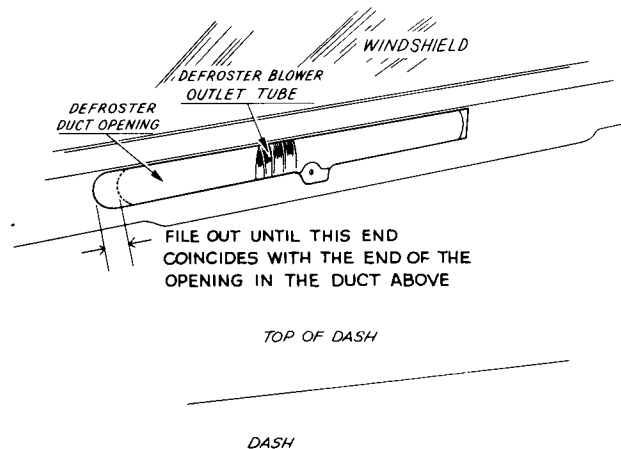
Conditions of too narrow a pattern of frost or mist removal from the windshield by the defroster on 1950 models may be caused by an excess of metal on the air duct panel overlapping the outside edge of the defroster air duct (see illustration).

To make the defrosting path wider, it is necessary to remove this metal as outlined in the following procedure:

8. Remove the right and left lower glass channel retainers.
9. File the outer ends of the defroster duct opening as required to match the opening in the glass channel retainer (see illustration).

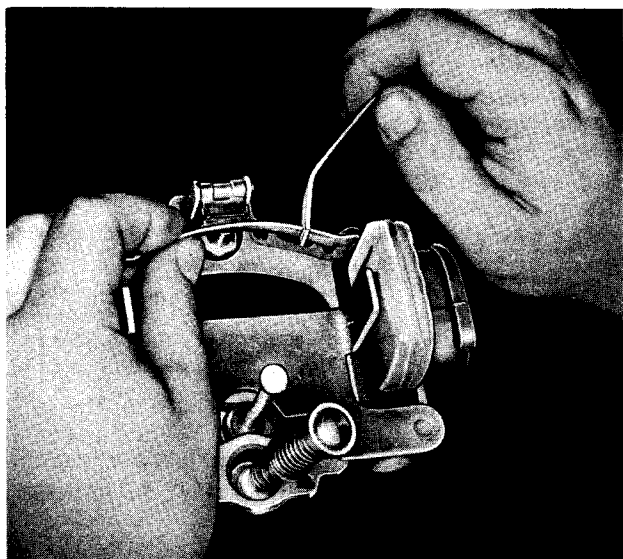
FIG. 1

The procedure for setting the float on the Stromberg Model AAQVB-26 carburetor used on Commander V-8 engines has been revised. To set the float level in this carburetor proceed as follows:

Place the Float Gage T-24971 on the cover gasket with the two lugs of the tool seating in the corresponding holes in the air horn. Using Tool KMO-269-S5, bend the float arms as necessary so that the floats are parallel to the vertical guides of the tool (see Fig. 1).

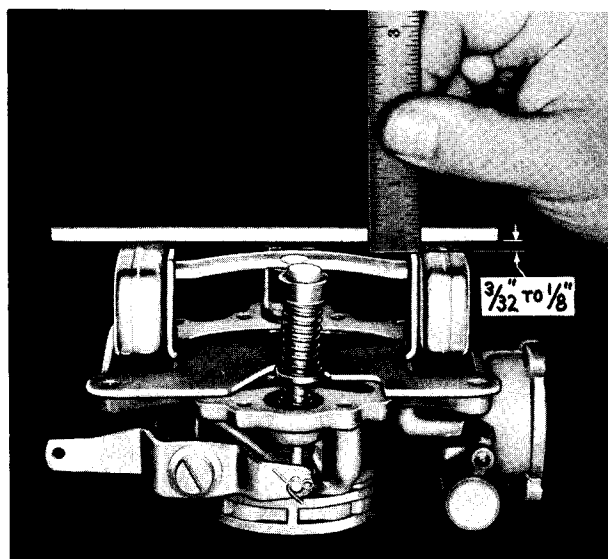
FIG. 2

Then, check the setting of each float. Place a straight edge across the highest point of the floats and measure the height of the floats above the vertical guides of the tool (see Fig. 2). This measurement should be from  $3/32''$  to  $1/8''$  (2,38 to 3,18 mm.). Both floats must be at the same height. With Tool KMO-269-S5 bend the float arms as required to obtain the proper float setting.
