Studebaker

SERVICE BULLETIN

NO. 248

STUDEBAKER AUTOMATIC DRIVE FOR 1951 COMMANDER AND LAND CRUISER MODELS

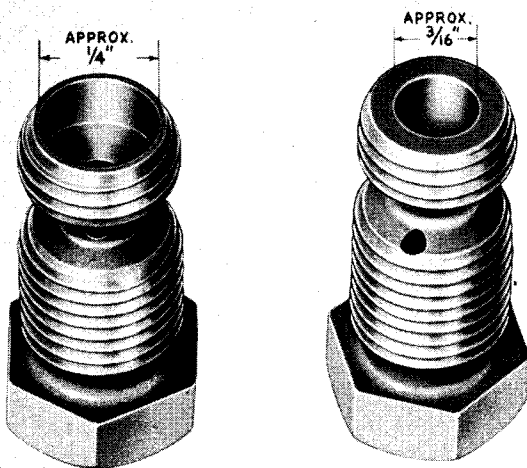
FIG. 1

If you encounter cases of repeated excessive valve clearance developing in a Commander V-8 engine, it may be caused by excessive wear in the push rod socket of the rocker arm adjusting screws. This condition would result from screws not being properly heat treated.

Premature wear may be found in the rocker arm adjusting screw of the type shown in Fig. 1. It has not been found in the type of screw shown in Fig. 2. When you have the condition of repeated excessive valve clearance occurring examine the rocker arm adjusting screws and replace all of the type shown in Fig. 1.

Order rocker arm adjusting screws, Part No. 529400, from your Parts Depot in the usual manner. Any of these screws you receive from your Parts Depot, regardless of type, will have the proper heat treatment.
