Studebaker

# SERVICE BULLETIN

MARCH

NO. 249

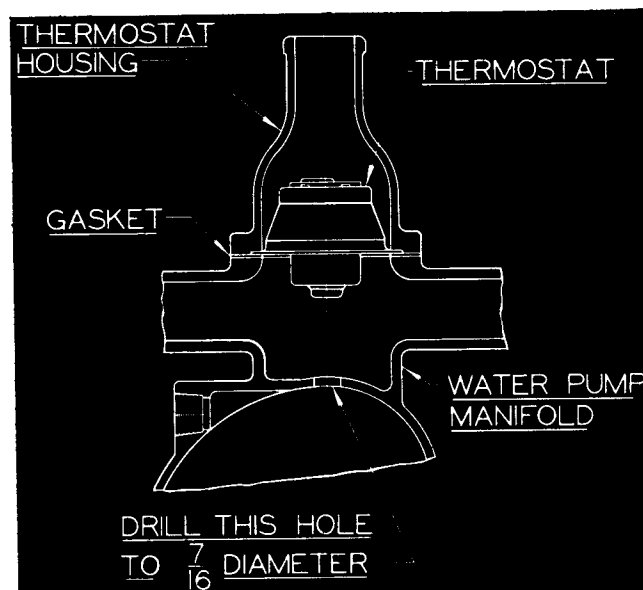
In the V-8 engine, if a situation of continued water loss during warm-up (before the thermostat opens), cannot be corrected in the usual manner of eliminating air binds, leaks at gaskets or hose connections, etc., the following correction will, in most cases, apply:

1. Remove the thermostat housing and the thermostat.
2. Enlarge the 5/16" by-pass hole with a 7/16" drill (see illustration).

This procedure will better equalize cooling between the right and left cylinder banks. The 7/16" by-pass hole entered production with Engine No. V-27454.

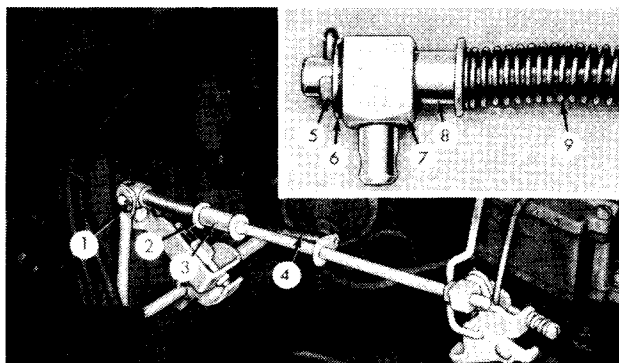
In order to assure manual opening of the choke valve by depressing the accelerator pedal to the floor board, the tension of the throttle rod overtravel spring on the cross shaft-to-carburetor rod has been increased on the Commander engines equipped with Automatic Drive. This change became effective in production with Serial No. 8129080.

The tension of the overtravel spring on cars before Serial No. 8129080 can be increased by installing a spacer and an additional washer on the cross shaft-to-carburetor rod.

1. Loosen the clamp screw and remove the carburetor air cleaner. Disconnect the pullback spring (4). Remove the swivel cotter pin (1), flat washer, and spring washer. Disconnect the cross shaft-to-carburetor rod from the cross shaft. Remove the cotter pin (5, see inset) from the end of the cross shaft-to-carburetor rod. Remove flat washer (6), swivel (7), flanged sleeve (8), and spring (9).
2. Install spacer (3) 3/4" long made of tubing with 1/4" inside diameter and a 1/4" flat washer (2) on the rod. Install the spring, flanged sleeve, swivel, flat washer, and cotter pin. Connect the cross shaft-to-carburetor rod to the cross shaft. Then install the spring washer, and cotter pin (1), and connect the pullback spring (4).

3. Check the adjustment of the pullback spring. This should be adjusted so there will be just enough tension to insure the full closing of the throttle. Be certain there is no interference present.
4. Depress the foot accelerator inside the car to full throttle opening. There should now be a minimum of 1/8" opening of the choke valve in the carburetor throat. If not, make the necessary adjustments. Refer to page 20 of the Gasoline System Section, 1951 Passenger Car Shop Manual.
5. Install the air cleaner assembly and tighten the clamp screw. Check the choke operation manually to be sure that it moves freely.

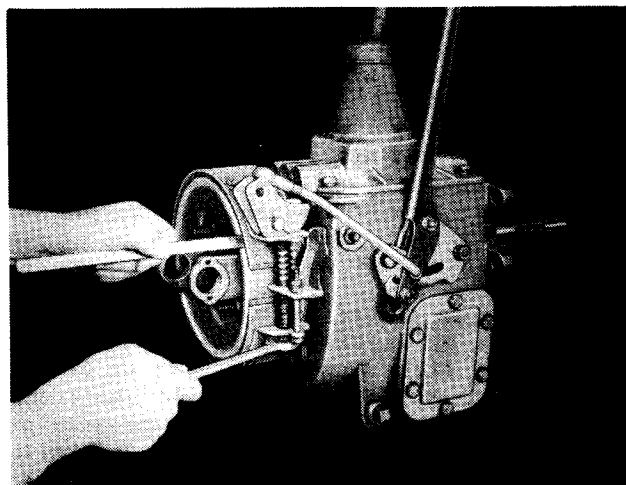
Effective with Truck Serial Nos. R17A-20060, R16A-30676 (T97 optional transmission), R16A-30880 (standard T9A transmission), R14-378, and R11-1774 the arrangement of the linkage of the band-type parking brake has been changed to eliminate interference at the power take-off.

The operating cam is now located on the brake band flange at the upper ends of the adjusting link, pin, and springs. The new arrangement can be installed on prior production trucks by using the following procedure:

1. Remove propeller shaft, transmission main shaft rear flange, brake band assembly, and brake drum.
2. Remove transmission case rear flange with bushing (Part No. 674893).

3. Remove brake rod from band brake lever.
4. Remove nut and stud that supports rear end of brake sector and install cap screw, Part No. 1-0616, with lock washer, Part No. 384-06. Coat threads with Permatex to prevent oil leak.

5. Install new transmission case rear flange with bushing, Part No. 680436.
6. Replace brake drum and flange and assemble brake band with the operating cam on the top and the cam bolt adjusting nut at the bottom.

7. Install 1/4" brake band adjusting bolt in original position.
8. On Models 2R5, 2R6, 2R10, 2R11, 2R14, 2R15 and 2R16A use new band brake rod, Part No. 680444; on Models 2R17A, and those 2R16A equipped with T97 Transmission, use new rod, Part No. 680446, and rod spacer, Part No. 680445. The spacer should be installed on the outside of brake lever to provide clearance between rod and cap screw in brake sector.

9. Adjust brake as outlined in 2R Series Shop Manual, page 259 (Supplement III).
