Studebaker

SERVICE BULLETIN

NO. 252

1951

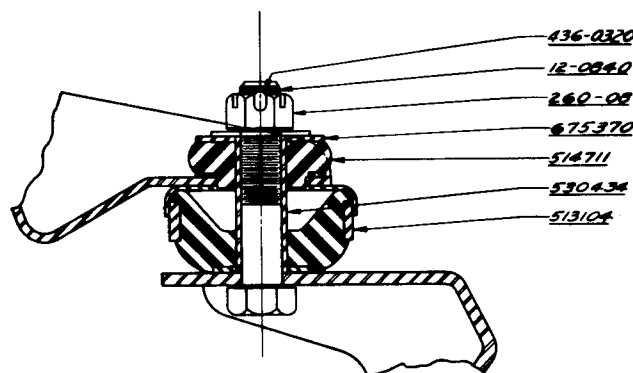
10G CHAMPION

Where experience on cars produced before the above serial numbers has shown that the engine front support bolts and other parts have come loose during shipment or operation, the new parts listed above can be installed as shown in the drawings at right. The Marsden nut on Commander models and the original lock washer and nut on Champion models may be discarded.

The new parts used for the Model 10G Champion replace the standard type lock washer and nut and are as follows:

Part No.	Part Name	For Model
436-032	Cotter Pin	10G
12-0840	Screw	10G
260-08	Castellated Nut	10G

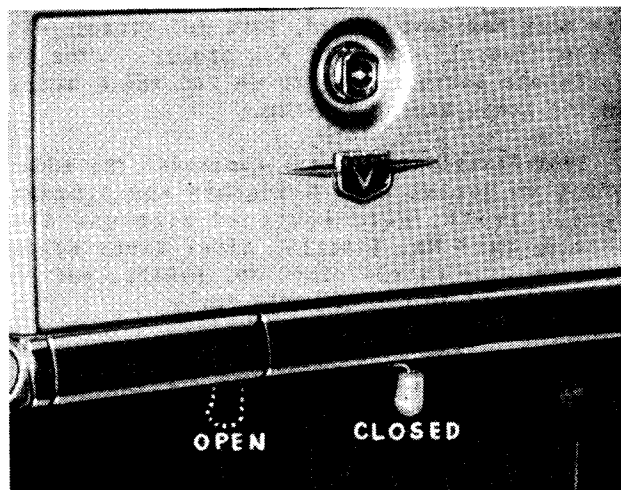
A new type of control for smoother operation of the outside right cowl vent door (on Left Hand Control cars) entered production with the following body numbers:

The new control is located just below the package compartment and is mounted to the underside of the instrument panel. It is a lever type control equipped with a knob (see

illustration) for ease of operation.

To open the vent door, move the lever to its full left position. To close the vent door, move the lever to its full right position.

The new control requires different vent door and attaching parts, so that it is necessary to order parts for service of the outside right cowl vent door or its operating control by body number.

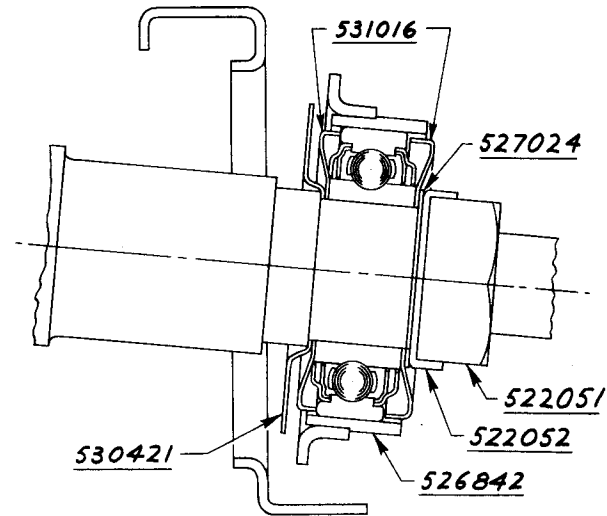
Failure of the propeller shaft center support bearing due to mud, sand, or water entering the bearing under severe operating conditions can be prevented by the use of bearing shields, Part Nos. 531016 and 530421.

On 1950 Champion (9G) and Commander (17A) models, maximum protection can be obtained with the installation of two Part No. 531016 shields, one on each side of the bearing. At the same time it will be necessary to replace the original dust shield, Part No. 523000, with a new type shield, Part No. 530421. (The new parts are shown installed on 10G and H models in the accompanying drawing.)

If additional protection against dust, mud, or water is desired in view of extreme operating conditions, one or two additional shields, Part No. 531016, can be installed as necessary so that there will be one shield, Part No. 531016, on each side of the bearing. (See drawing.)

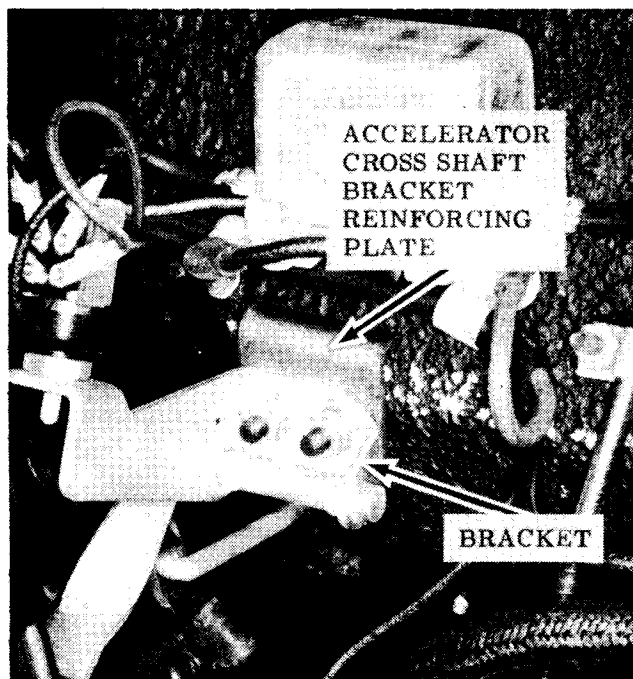
To prevent the possibility of the accelerator cross shaft bracket from becoming embedded in the insulation material on the front of the

firewall and thereby making inoperative the kickdown switch on overdrive equipped 2R Series trucks, a reinforcement plate, Part No. 680727, has entered production effective with truck Serial Nos. R5-74940, R6-2599, R10-30498, and R11-2356.

To install the reinforcing plate on trucks with overdrive transmissions before above serial numbers, remove and discard the original cross shaft bracket bolts and insert the reinforcing plate between the bracket and the firewall with the radius on the reinforcing plate uppermost (see illustration). Then install two Part No. 2-0414 bolts, using the original lock washers and nuts.
