Studebaker

SERVICE BULLETIN

NO. 262

1952

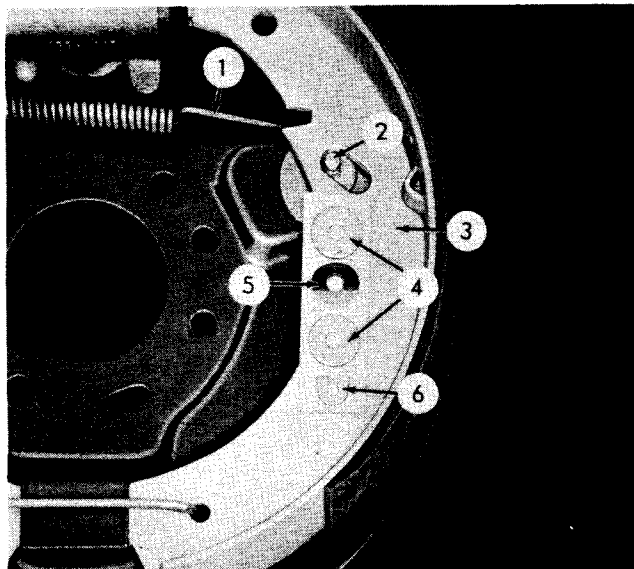
FIG. 1

Self-adjustment of the reverse shoe is accomplished by removing the shoe retracting spring, thus permitting the lining to conform and lie close to the drum surface at all times, regardless of lining thickness. Since the shoe-and-lining assembly is de-energized (tends to "unwrap") in the direction of forward drum rotation, it offers no appreciable drag. Friction washers at the eccentric pin and slotted hole (5, Fig. 1) in the shoe web prevent the lining from following slight irregularities in the drum. In reversing the car, the reverse shoe becomes slightly self-energized and there may be a light drag. This drag does not cause abnormal lining wear.

1. The continuous contact of reverse shoe lining to drum is normal. *It is not a brake drag.* Service men must learn to recognize this contact and should not attempt to adjust the reverse shoes to eliminate it. It will not cause abnormal reverse shoe lining wear.
2. *There is no mechanical adjustment required for the floating reverse shoes.* The eccentric (2, Fig. 1) need not be touched for any adjustment purpose. The normal position is in full release. The eccentric pin acts as

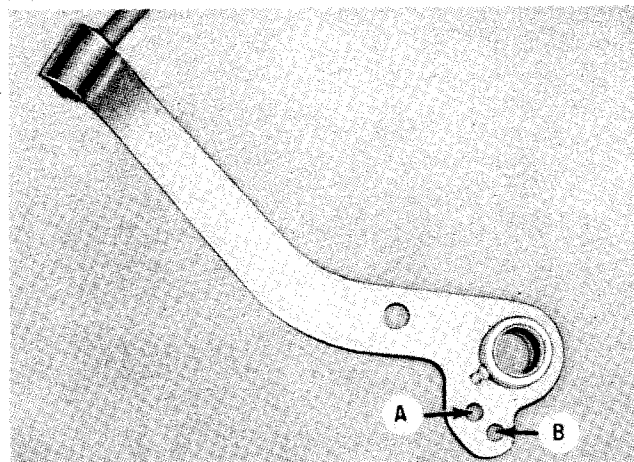
FIG. 2

The change in linkage is shown in Fig. 2, which shows holes A and B in the brake pedal arm. On 1952 Commander (3H) models, hole A is used for the new master cylinder-to-brake pedal rod, Part No. 531865. Champion (12G) models use hole B for the master cylinder-to-brake pedal rod connection.

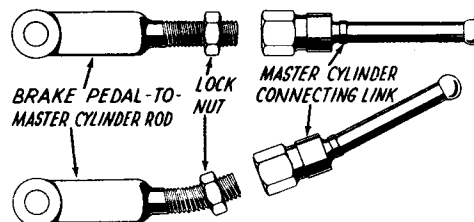
FIG. 4

THE BRAKE PEDAL-TO-MASTER CYLINDER ROD AND THE MASTER CYLINDER CONNECTING LINK AT THE TOP OF THE DRAWING ARE STRAIGHT, NORMAL, UNDISTORTED. THESE PARTS ARE ALL RIGHT TO USE. AT THE BOTTOM, THE BRAKE PEDAL-TO-MASTER CYLINDER ROD IS BENT ALONG THE THREADED PORTION, WHILE THE MASTER CYLINDER CONNECTING LINK IS SLIGHTLY BENT AT THE SHOULDER END OF THE SHANK. BOTH OF THESE PARTS, IF FOUND, WOULD BE DISCARDED.

Excess or increase of brake pedal free travel (3) has several causes: (a) bent brake pedal rod (Fig. 4), (b) bent master cylinder connecting link (Fig. 4), (c) loose adjustment lock nut, or (d) loose master cylinder mounting bolts.

(c) INSPECT BRAKE PEDAL-TO-MASTER CYLINDER ROD AND ALSO THE MASTER CYLINDER CONNECTING LINK CAREFULLY FOR STRAIGHTNESS. If either part appears to be bent or damaged in any way or to any degree, discard it.

(d) Reassemble, using new parts if necessary (Part No. 523924, Master Cylinder Connecting Link; Part No. 531865, Pedal-to-Master Cylinder Rod), and adjust brake pedal free travel to specifications (1/16" to 3/16"). Tighten lock nut.

Do not adjust the master cylinder connecting link to correct excessive pedal free travel until after inspecting for a bent link or bent brake pedal-to-master cylinder rod.

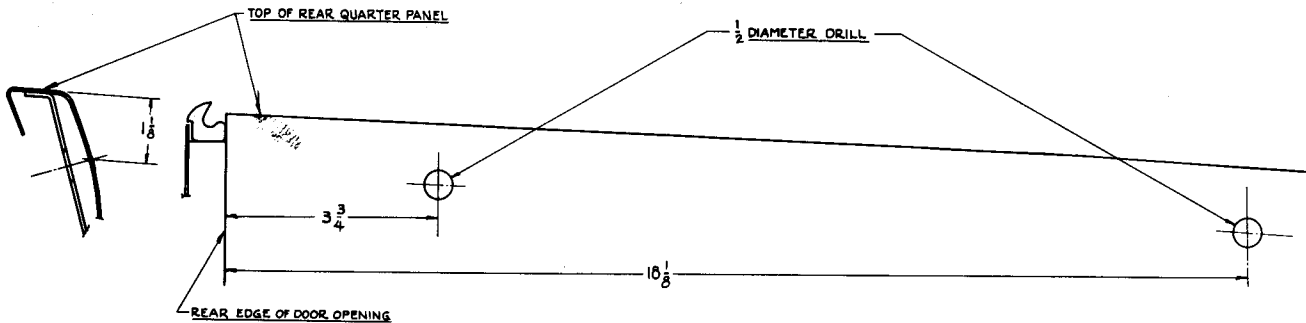
FIG. 7

Effective with 12G Champion Serial No. G-1141024 and 3H Commander Serial No. H-8,250,134 the rear quarter panel belt moulding on Starliner models will be held in place by means of two studs instead of the clips and snap-on buttons used prior to the above serial numbers.

For installation of the new type moulding piece (Part No. 295944-5) on earlier production cars it will be necessary to drill two 1/2" diameter holes in the upper portion of the rear quarter panel as shown in the accompanying illustration (Fig. 7). The purpose of the oversize holes is to permit adjustment of the moulding location. The following parts must also be used:

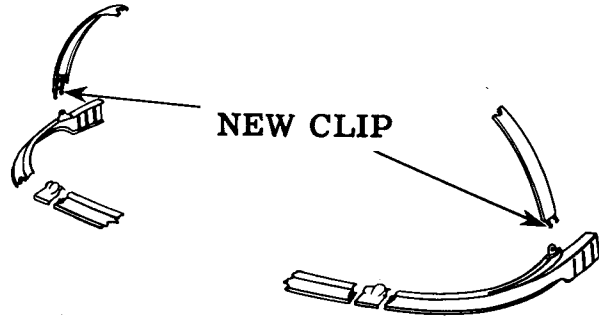
FIG. 8

Originally the roof rear window moulding side piece on each side of 1952 Starliner bodies was held in place by a screw at the top and two clips along the side of the moulding. This piece has been changed to incorporate a clip riveted to the lower end of the moulding side piece so that the clip slips in behind the

A little material has been removed from the belt moulding to accommodate the added clip in the roof rear window moulding side piece.

The new side piece can be used on cars equipped with the original type if the attaching screw of the belt moulding is loosened slightly so that the clip on the side piece can be slid behind the moulding.

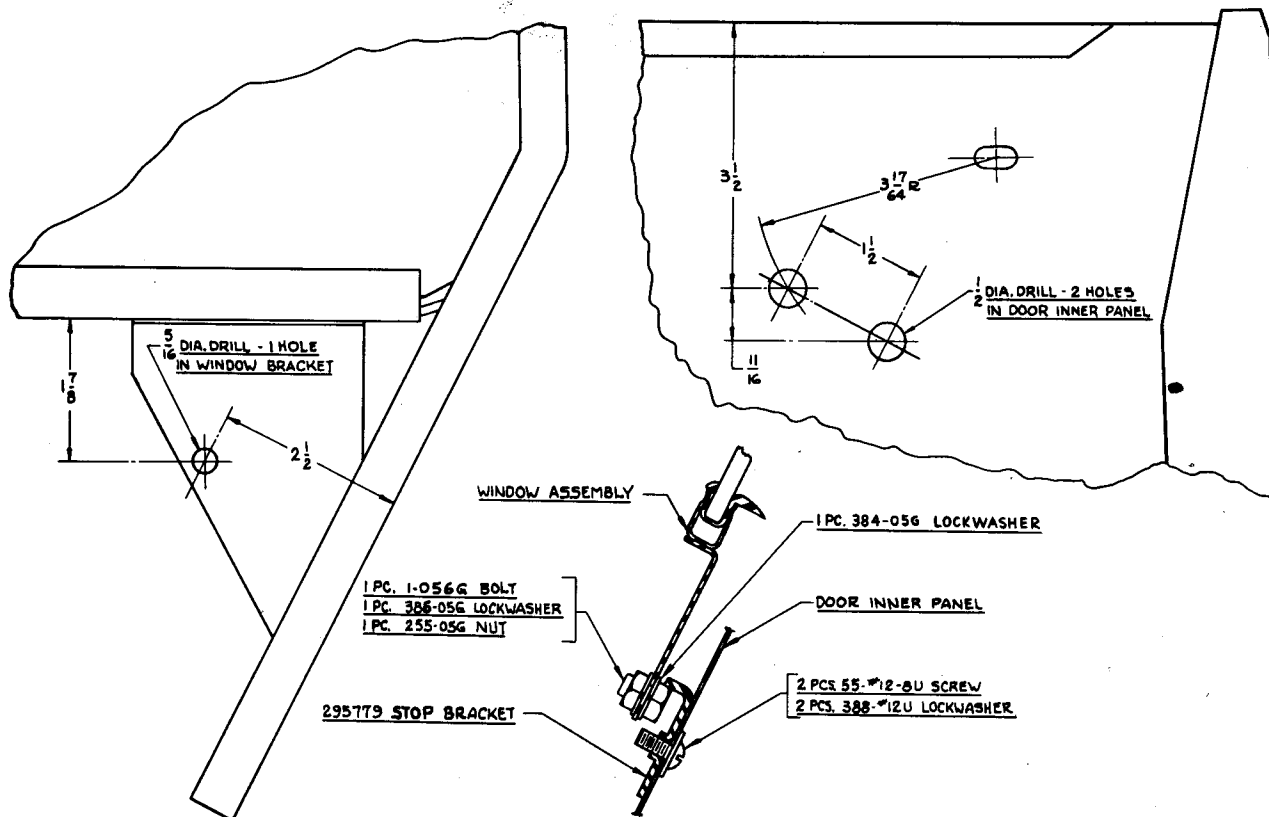
FIG. 9

To provide a positive stop when raising the door glass of 1952 Champion and Commander convertible and Starliner models a bracket is being incorporated in production effective with Body Nos. 12G Champion Starliner 2327 and Convertible 207; 3H Commander Starliner 5187 and Convertible 295.

When it is desirable to install such a stop on cars previously built, refer to the drawing (Fig. 9) at each step and proceed as follows:

1. Remove door window glass assembly from door and drill a 5/16" hole in the door window bracket at the location shown in the drawing.
2. Drill two 1/2" diameter holes in door inner panel at the locations shown in the drawing.
3. Replace door glass assembly in door. Install 386-05G lock washer on the bolt and in the hole drilled in the door window bracket. Then install 384-05G lock washer and 255-05G nut on the bolt.
4. Lower window so that nut and bolt just installed in window bracket is below location of stop bracket and install the stop bracket in the door panel.

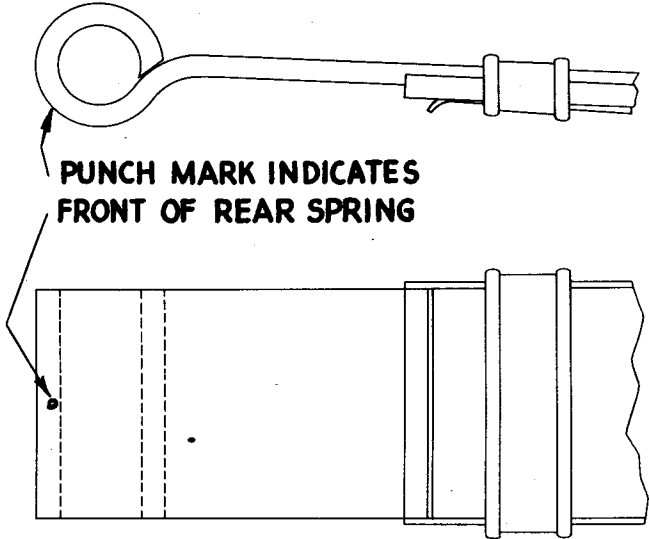
FIG. 10

In order to assure that these springs are installed properly, a dimple is punched into the outer surface of the front eye (see Fig.10). Rear springs should always be installed, therefore, with this dimple toward the front of the car.
