Studebaker

SERVICE BULLETIN

NO. 241

1950

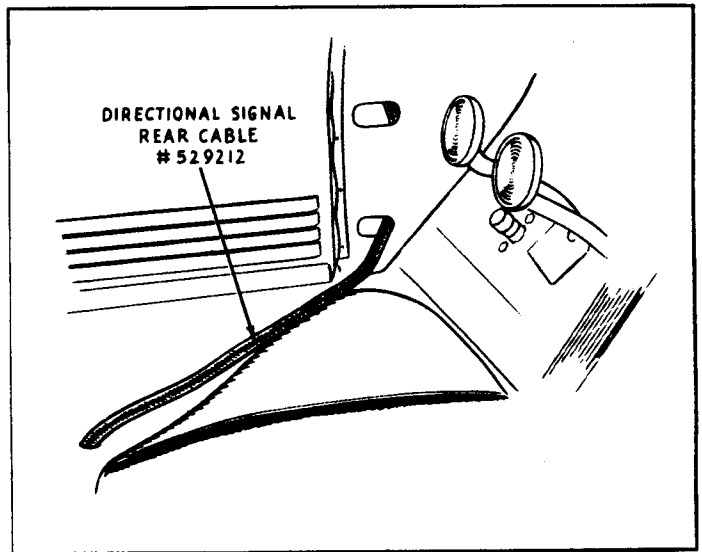
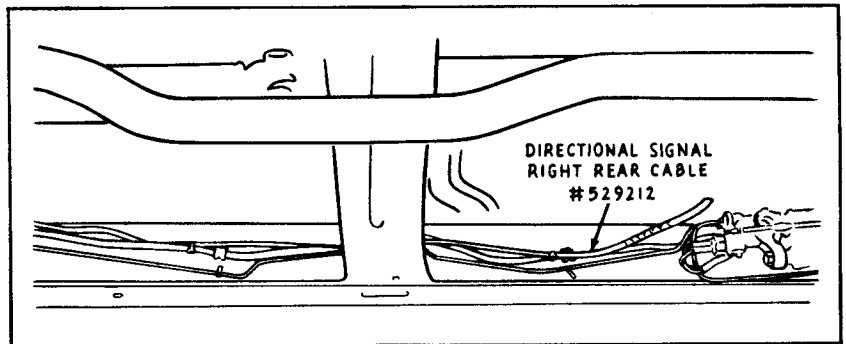
CHASSIS WIRING (UPPER) HARNESS

If you have stocks of old style lighting kits, AC-1881 or AC-1882, on hand then it will be necessary to use an adaptation kit when making an installation in cars with the new style harness. This adaptation kit for the directional signals, AC-150, is available at a net price of \$1.75, as was outlined in Parts Department Letter No. 77, dated April 25, 1950.

The following table shows the part numbers of the various harnesses and lighting kits involved. When your stocks of the old style cables are depleted only the new style will be furnished from your parts depot.
